National Register of Historic Places
Continuation Sheet

University Area Historic District Addendum III
 Missoula, Montana

Patterson Building, 610/612/614 South Higgins Avenue

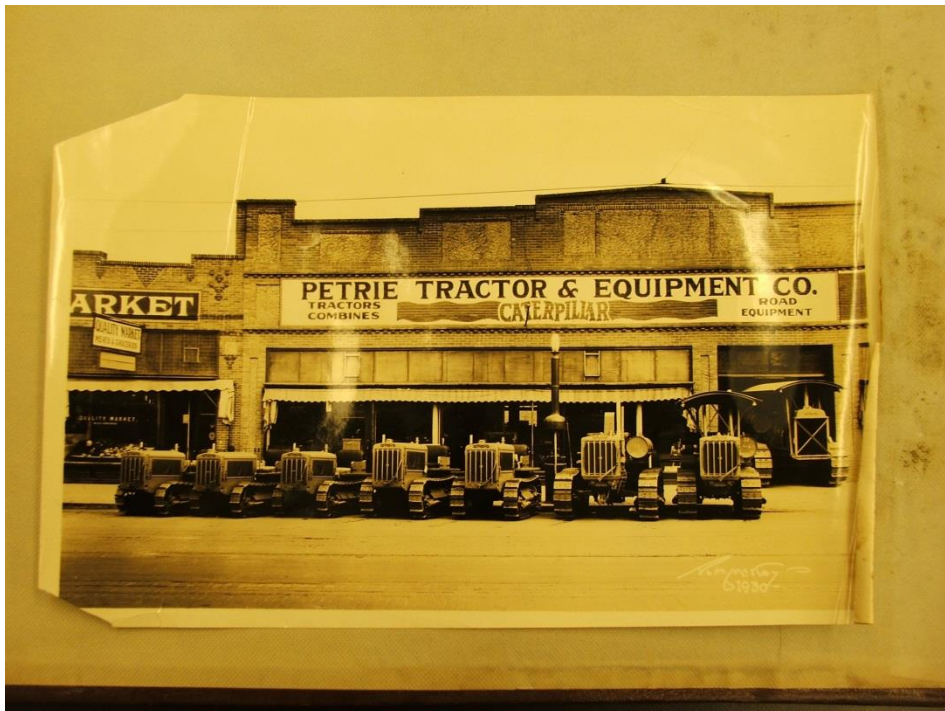
Description of Photograph(s) and number, include description of view indicating direction of camera: West Elevation, view to the east. Circa 1930 photo of building, partially visible in far left of photo.

Historic photographs were found that illustrate how the exterior looked during the 1910s and 1920s. Based on the available evidence, a new storefront was designed with historically-compatible materials and configuration. The three entrances were reestablished; two located near the north and south exterior walls, and one centrally located on the façade. New doors are 3' wide, single-lite, metal-framed units with transom above in recessed openings. Octagonal, glazed tile vestibules lead into the commercial spaces. Display windows are single-lite, fixed-pane, storefront windows in anodized, metal frames, with wood-paneled bulkheads and display cases, below.

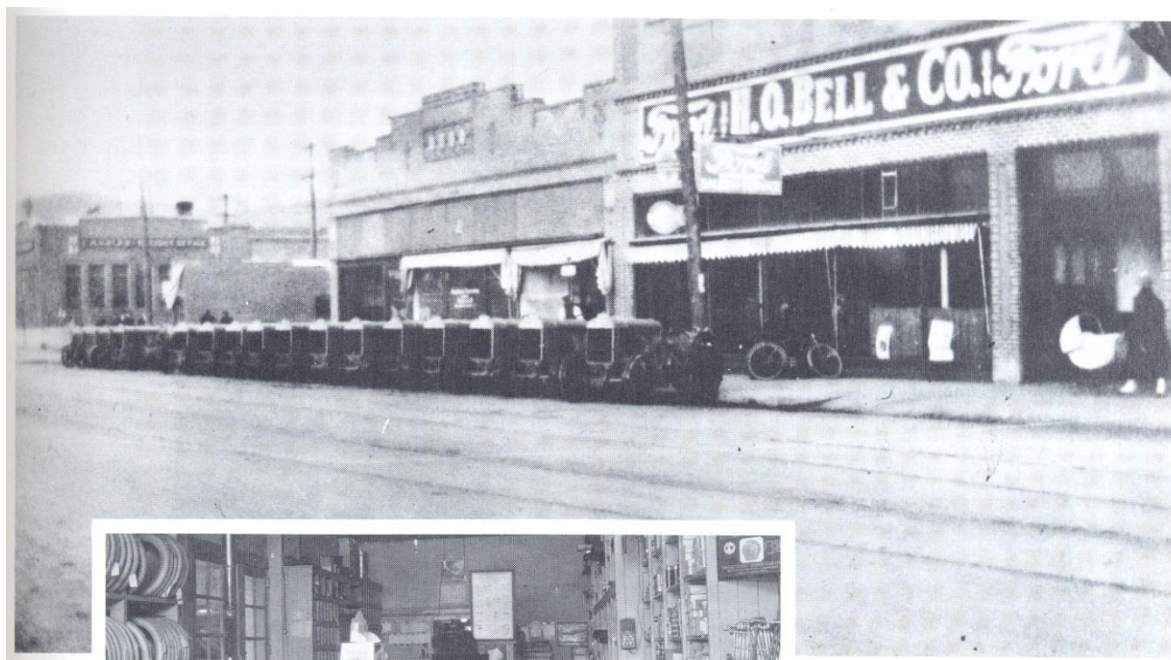
Description of Photograph(s) and number, include description of view indicating direction of camera: West Elevation, view to the northeast. Photo of Patterson Building from 1916.

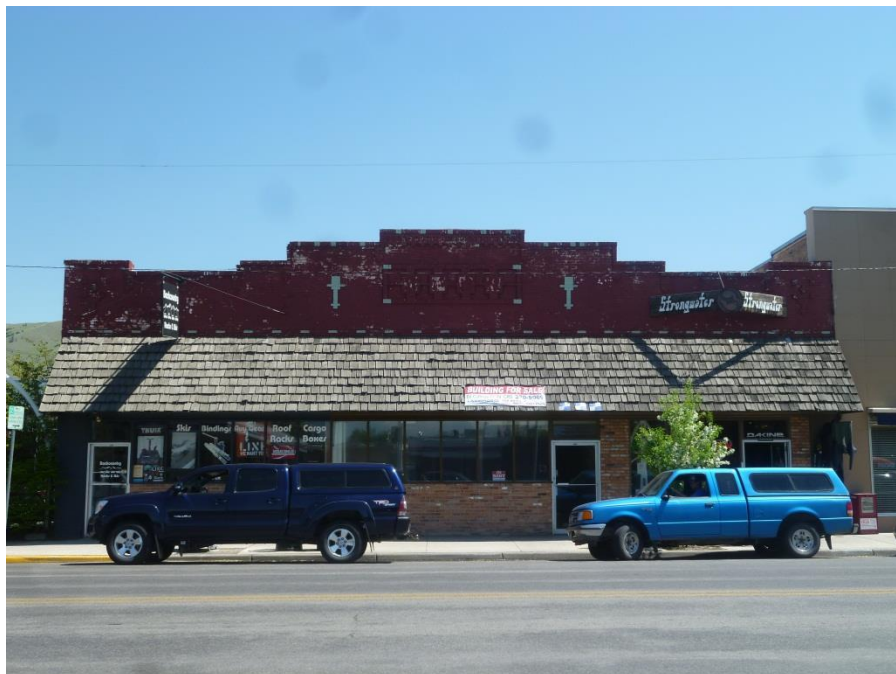
Photograph Number: MT_UniversityAreaHistoricDistrictAddendumIII_0001

Description of Photograph(s) and number, include description of view indicating direction of camera: West Elevation, view to the east. Front of Patterson Building before rehabilitation.

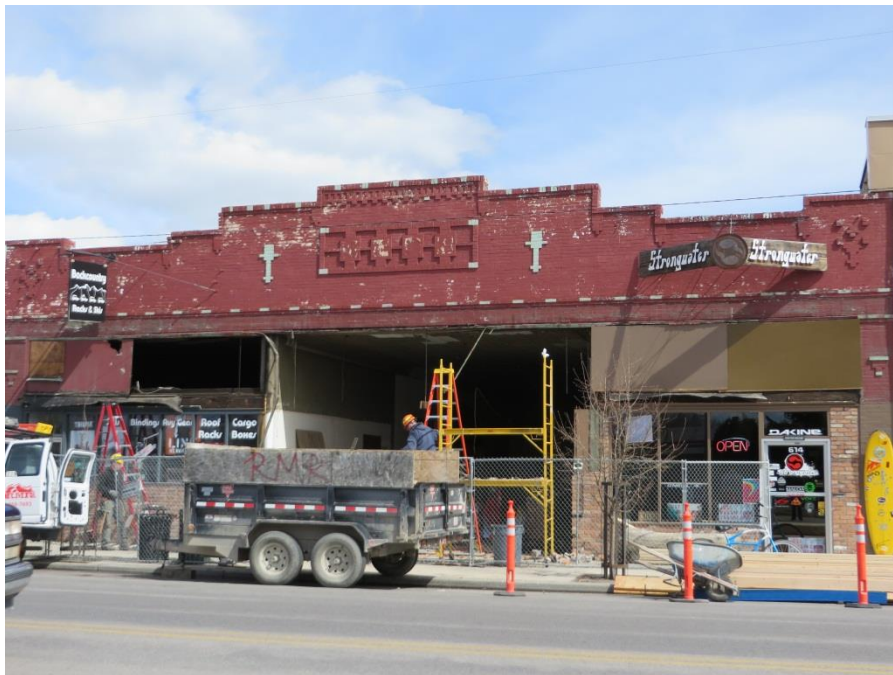
Photograph Number: MT_UniversityAreaHistoricDistrictAddendumIII_0002

Description of Photograph(s) and number, include description of view indicating direction of camera: West Elevation, view to the east-northeast. Front of Patterson Building during rehabilitation.

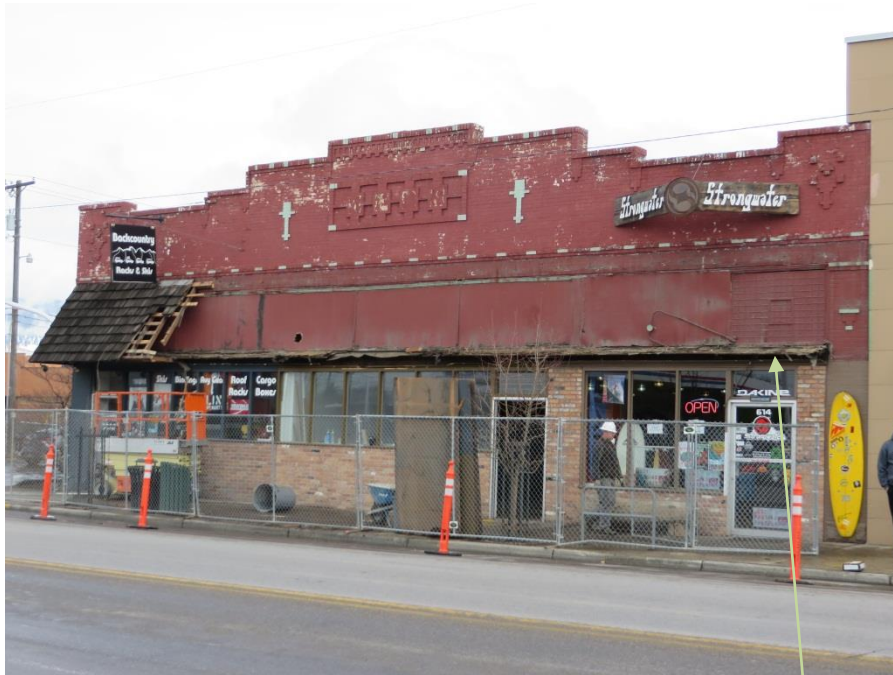
Photograph Number: MT_UniversityAreaHistoricDistrictAddendumIII_0003

Description of Photograph(s) and number, include description of view indicating direction of camera: West Elevation, view to the east-northeast. Front of Patterson Building during rehabilitation, wooden awning removal showing prismatic glass tiled panel.

The primary elevation includes three roughly equal storefronts enframed by brick pilasters, a prismatic glass transom, and a stepped parapet above the transom. The structure measures 21' in overall height, stepping up to a decorative brick inset panel at the midsection of the parapet, which is capped by brick coping. Polychromatic, geometric brick patterns adorn the parapet, and a “ghost sign” dating to the 1920s reminds passersby that the building once housed the “Quality Market.” Recessed entries lead to three interior commercial spaces, and new storefront display windows provide a visual connection to the public Right-of-Way. The original cast iron columns provide structural bearing points between the 2'3"-wide corner pilasters and support the prismatic, colored glass transom and masonry parapet that span the width of the structure above. Sections of the original transom survived intact and served as a template for the new glass block panels. The transom comprises nine

6'1" x 4'0" sections of 3" x 3", purple-tinted, prismatic glass blocks set in anodized metal frames.

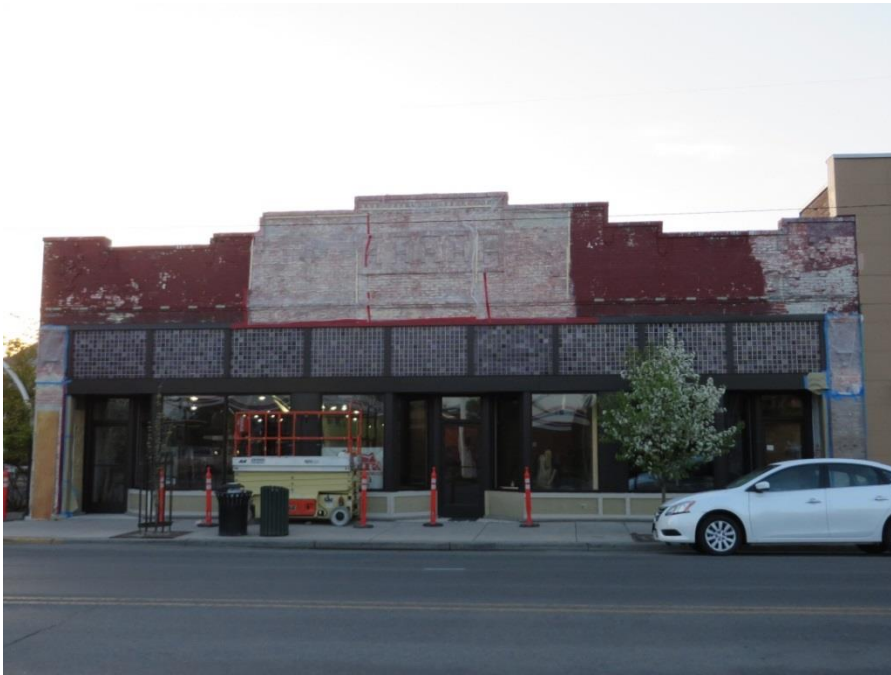
Photograph Number: MT_UniversityAreaHistoricDistrictAddendumIII_0004

Description of Photograph(s) and number, include description of view indicating direction of camera: West Elevation, view to the east. Front of Patterson Building during rehabilitation, Prismatic glass tiled transom panels installed and paint removal.

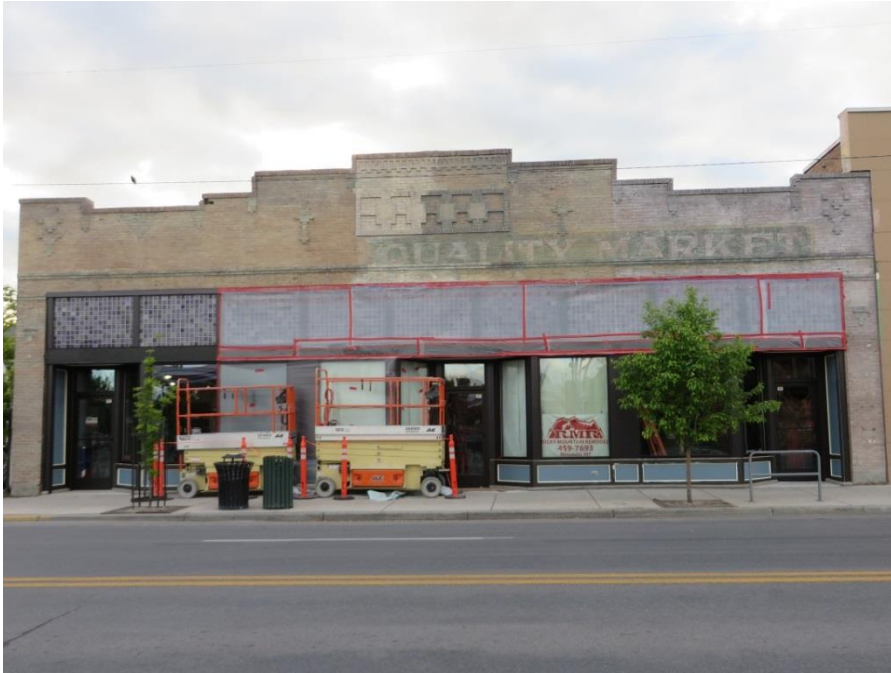
Photograph Number: MT_UniversityAreaHistoricDistrictAddendumIII_0005

Description of Photograph(s) and number, include description of view indicating direction of camera: West Elevation, view to the east. Front of Patterson Building during renovation, last of the paint removal, ghost sign visible.

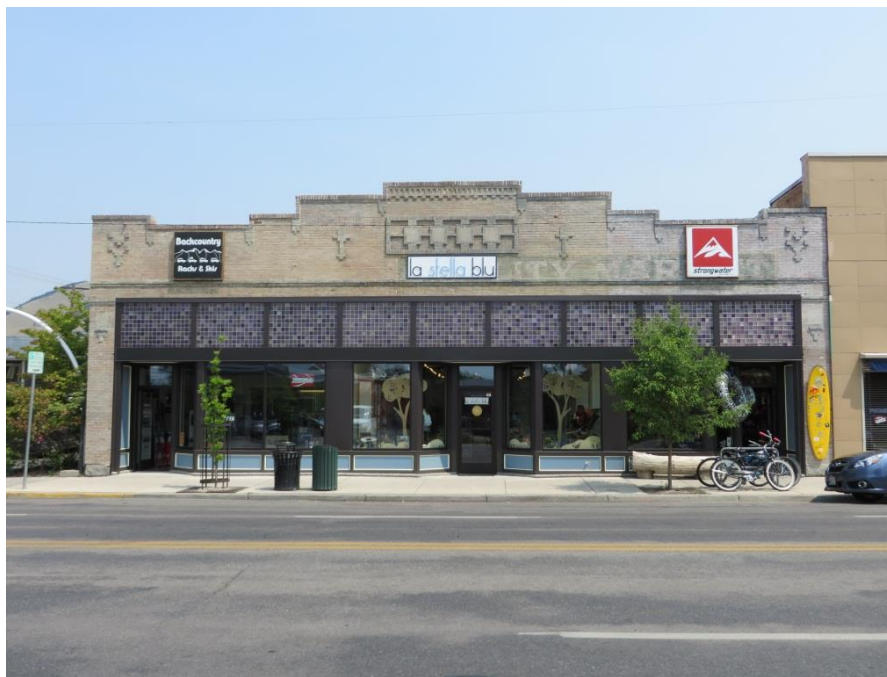
Photograph Number: MT_UniversityAreaHistoricDistrictAddendumIII_0006

Description of Photograph(s) and number, include description of view indicating direction of camera: West Elevation, view to East. Front of Patterson Building after rehabilitation.

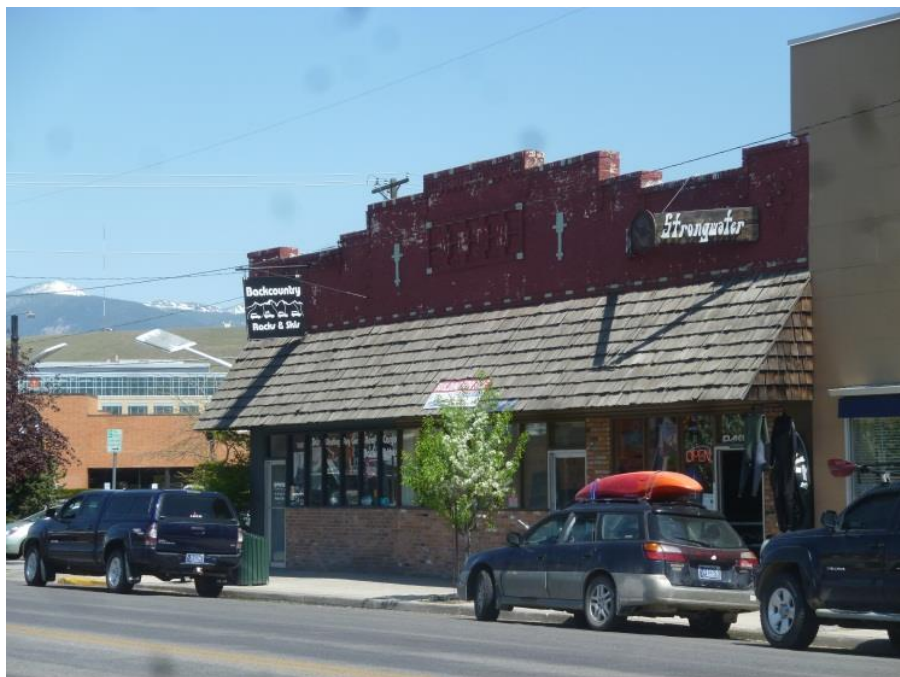
Photograph Number: MT_UniversityAreaHistoricDistrictAddendumIII_0007

Description of Photograph(s) and number, include description of view indicating direction of camera: West Elevation, view to northeast. Front of Patterson Building before rehabilitation, 2013.

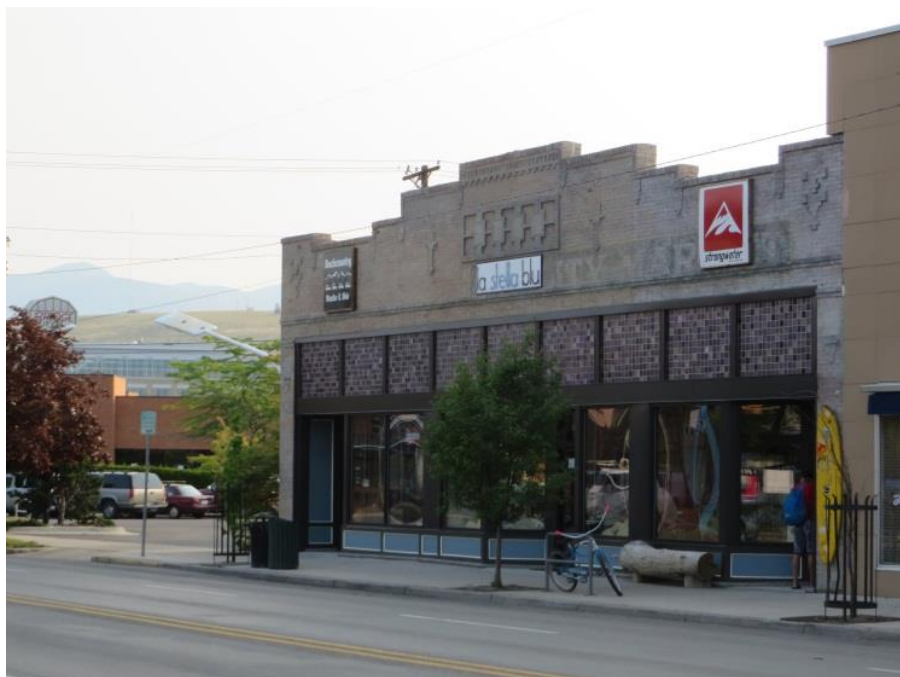
Photograph Number: MT_UniversityAreaHistoricDistrictAddendumIII_0008

Description of Photograph(s) and number, include description of view indicating direction of camera: West Elevation, view to northeast. Front of Patterson Building after 2014 rehabilitation.
